# Manhole Inspection Summary

Manhole # S31K\_\_003MH

Insp Date: **12/23/08 9:18 AM**

**Location** Address: **Russel St**

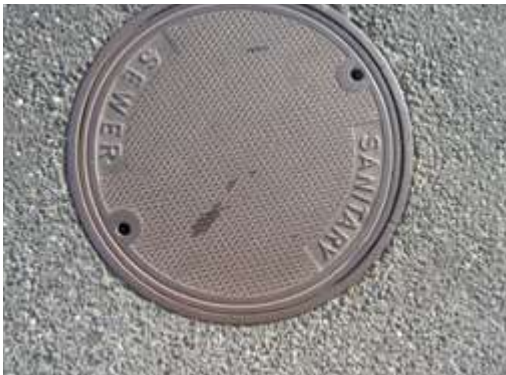
Miscellaneous

MH cover

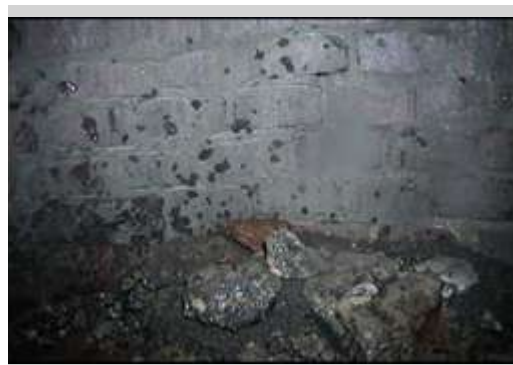
Defect 4

Condition: ☐ Sound ☐ Cracked ☐ Root Intrusion ☐ Deteriorated ☐ Leaks ☒ **Debris**

bench debris

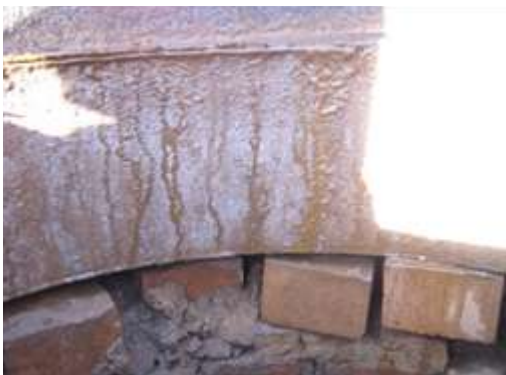
Defect 5

☒ **Leaks**

Condition: ☐ Sound ☐ Cracked ☐ Root Intrusion ☒ **Loose Brick** ☒ **Deteriorated**

frame leaks; chimney deteriorated with loose bricks

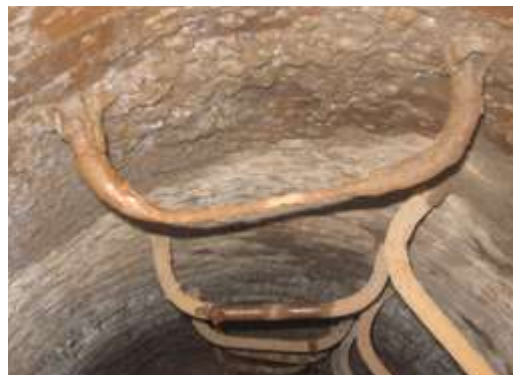
Defect 2

Infiltration: ☐ None ☐ Joint ☐ Cracks ☐ Mortar ☐ Roots ☒ **Wall**

Count: **10** Missing: **1** ☒ **Corroded**

steps corroded, corbel infiltration at wall

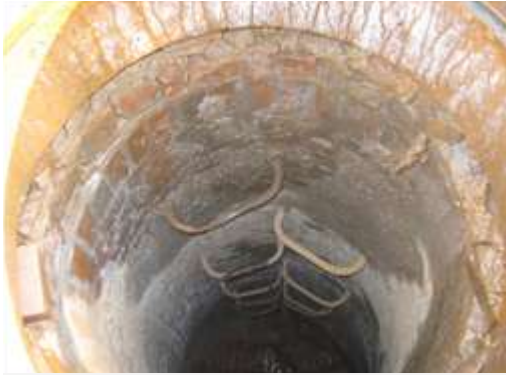
### Defect 1

Infiltration: ☐ None ☒ **Joint** ☐ Cracks ☒ **Mortar** ☐ Roots ☒ **Wall**

step missing; chimney infiltration at frame joint, mortar, & wall
